Church of St Mary
Houghton-on-the-Hill

This booklet tells the story of Houghton-on-the-Hill throughout its history, drawing on what we know about the deserted village and the surrounding landscape, the church and its unique wall paintings.

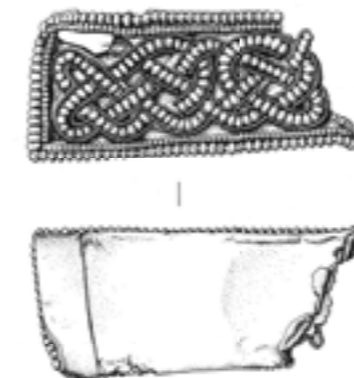
Fig 4: Saxon strapwork found near the river
 Norfolk Museums and Archaeology Service: Sue White

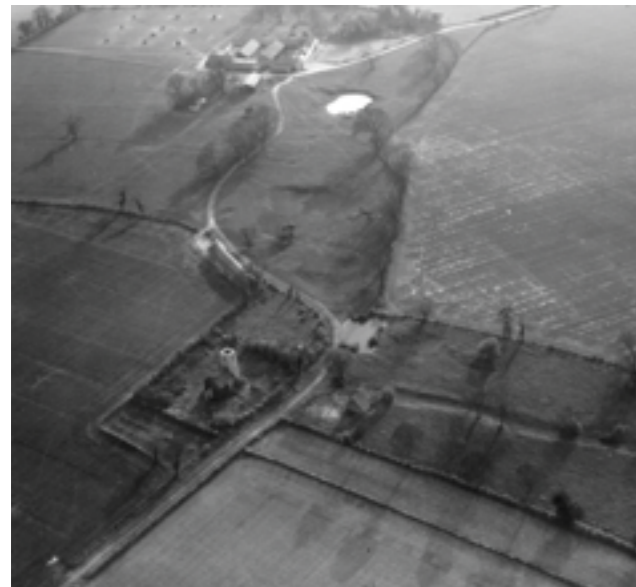
Fig 5: Aerial view of the deserted village showing the hollow way to the right of the church.

The village lay on the valley slopes to the north of the church, overlooking the Wissey, but seems to have shrunk during the late middle ages. Surviving earthworks consist of a hollow way, which would have been the main street in the village, running north from the church. To the left (west) of the track are ditched or scarped enclosures - raised platforms or *tofts* on which houses were built and enclosed. **Fig 5**

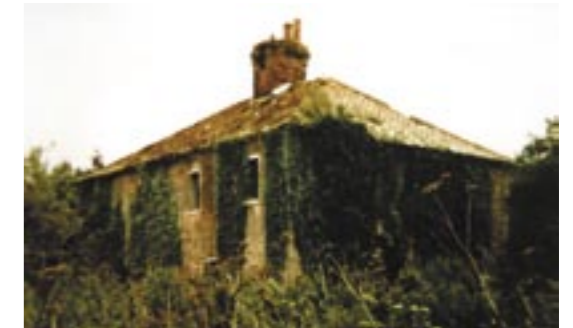
Fig 6: Cottages near the church, demolished in the 1990s

By the 18th century only a pair of cottages remained by the church, which Blomefield described as 'a cottage or two' on his visit. The tiny hamlet seems to have migrated from the spot north of the church, along the green lane, to form a small cluster of cottages on the edge of Houghton common. This may have occurred during the late medieval period when many villages drifted from their original sites to re-form around commons where livestock could be grazed. The cottages by the church survived until the 1990s by which time they had become derelict, and were demolished. **Fig 6**

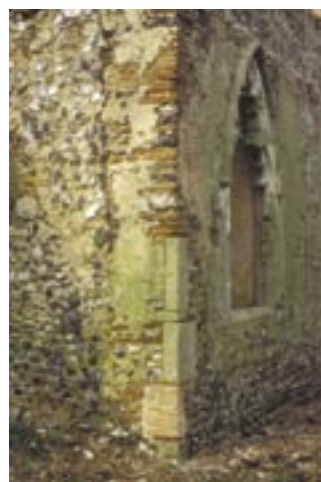
Long and short work: This is where lengths of cut stone were used to form corners in a pattern of long thin sections set vertically interspersed with short horizontal pieces. **Fig 10**

Fig 10: Long and short work and Roman brick, 'a' on plan

Re-used Roman brick: Roman brick looks like thick clay tiles. They were salvaged from the ruins of Roman buildings. There is evidence of a Roman villa near by which could have been the source for the bricks used here (see page 3). **Fig 10**

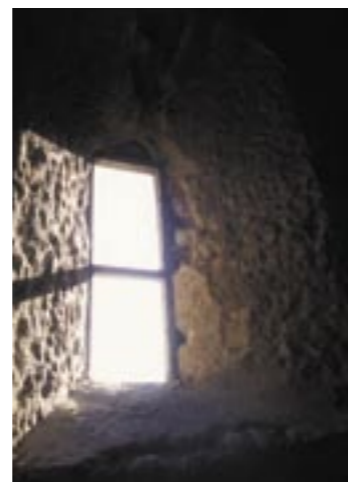
Double-splayed windows: In these windows the frame, forming a small opening, is positioned in the centre of the thickness of the wall. Splays in the fabric around this frame, both inside and out, direct light into the building. **Fig 11** The blocked double-splayed window in the north wall at Houghton still retains its original timber frame – a very rare survival. The two windows, high up on either side of the nave were the only source of natural light when the nave was built.

Fig 11: Double-splayed window, 'b' on plan

The undeveloped simplicity of the nave's double-splayed windows and plain chancel arch at Houghton suggests that it was built no later than 1100. The mid-12th century north doorway - with its tiny external shaft supporting a miniature Romanesque cushion capital - is inserted into the original nave wall, which must therefore be earlier. (**'d' on plan**)

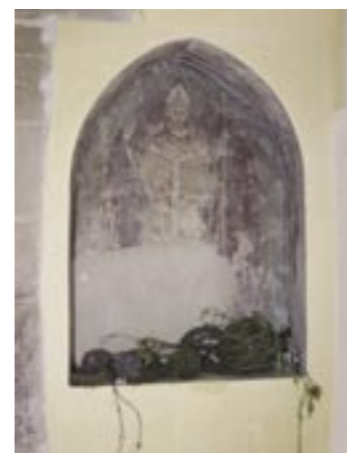
Fig 13: Example of niche altar at Hauxton in Cambridgeshire

This chantry chapel, and the Guild's chapel (see page 4) may have had altars in the niches in the east nave wall. (**'e' on plan**) Altars in this position were common, although niches created for them in the thickness of the wall are found less often. **Fig 13**

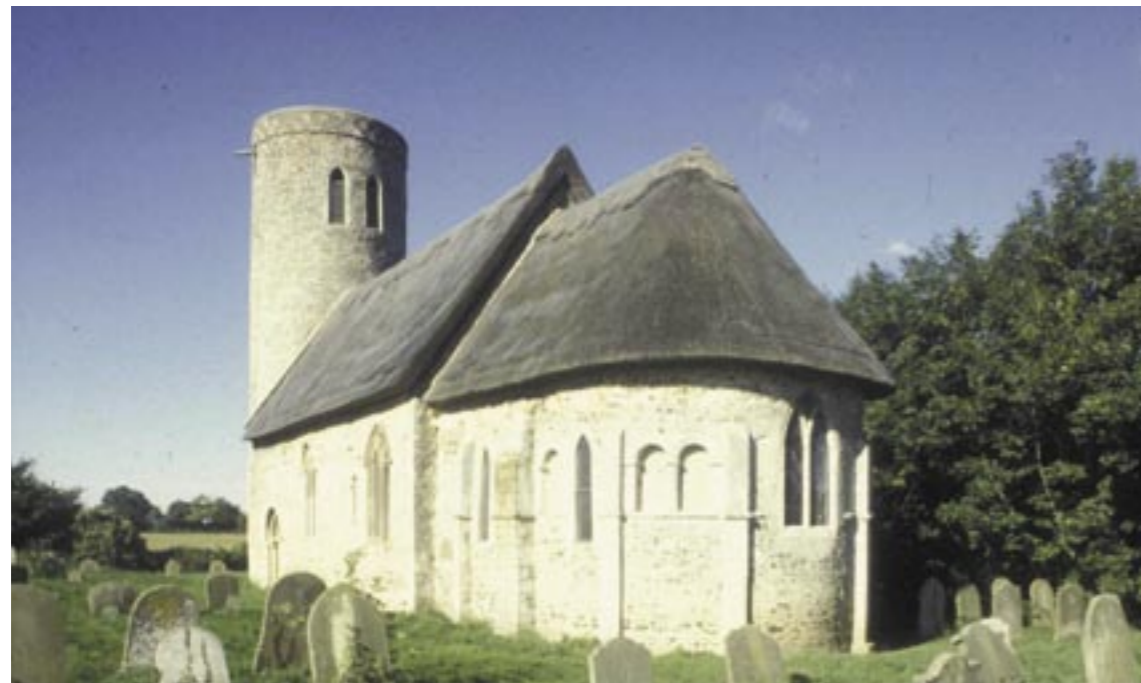
Fig 14: Semi-circular chancel at Hales near Loddon, Norfolk. The original chancel at Houghton-on-the-Hill may have looked like this

The original Romanesque chancel was constructed at the same time as the nave. **Fig 8a** It is likely that the chancel had a semi-circular or *apsidal* east end as was usual in the 11th century. **Fig 14**

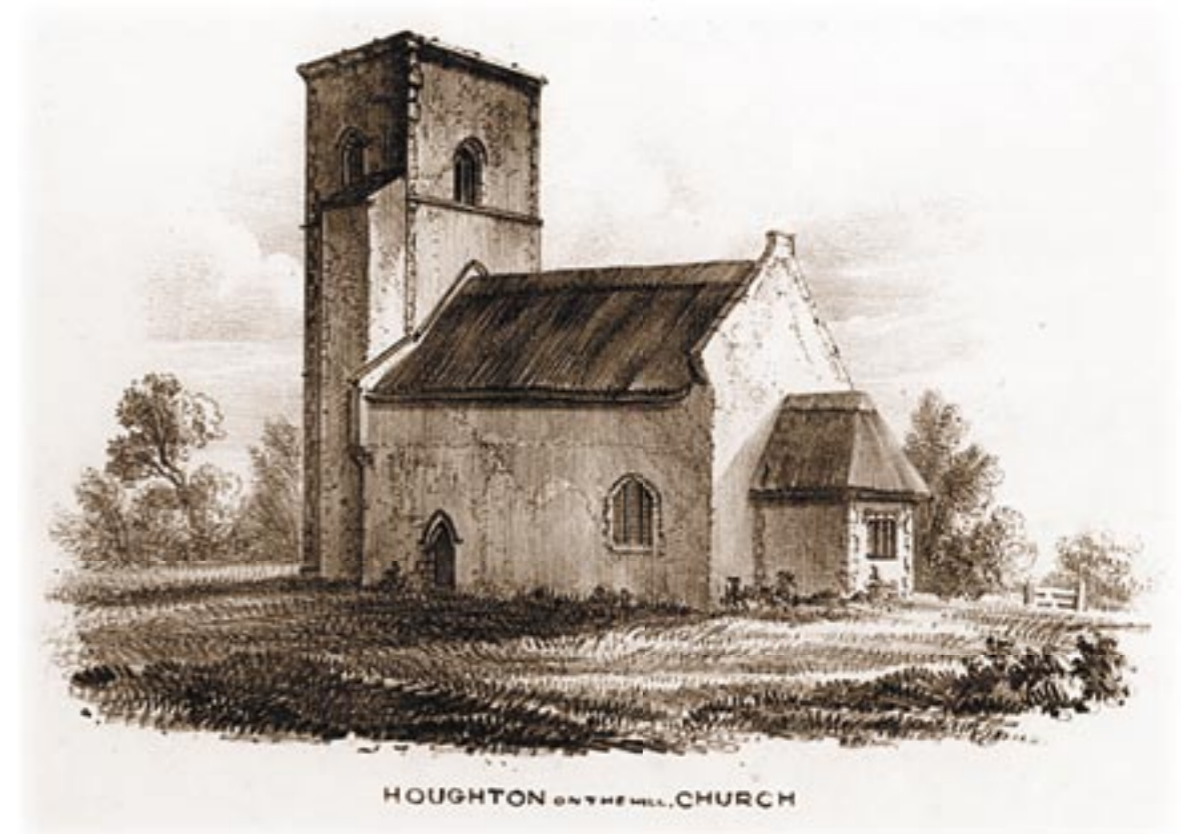
Fig 15: St Mary’s church drawn by Ladbroke 1830

11th century chancels were seldom so long. It is more likely that the original chancel was extended during the 14th century, when alterations were also undertaken in other parts of the church. **Fig 8c** Ladbroke’s drawing of circa 1830 shows the double-splayed openings blocked and there is a suggestion that the external walls of the nave were rendered, which could have hidden their age, and led to Blomefield’s mistake. **Fig 15**

In fact the new chancel was much smaller than the one proposed – only nine feet long and thirteen feet wide. **Fig 15**

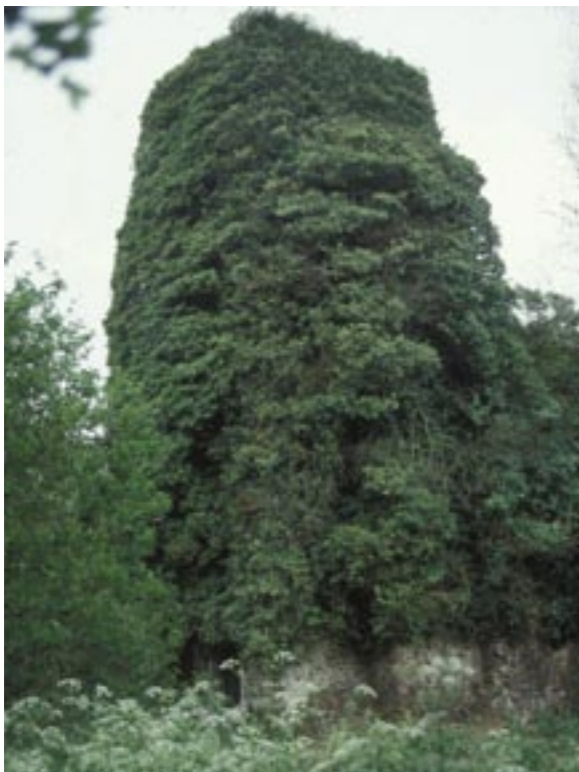
Fig 16: St Mary's church in the 1990s

By the early 1990s the roofs of the nave and chancel were in ruins, and the whole church was shrouded in ivy. **Fig 16** Then two events occurred which transformed the fortunes of the church. Bob and Gloria Davey moved to the village and became committed to saving the abandoned ruin after finding evidence of Satan worship at the isolated spot. At around the same time the County Council began a programme of repairs to ruined churches in the county and included St Mary's on its list. The initial repairs to re-roof the building and make it safe were funded by Norfolk County Council, English Heritage and Breckland Council. **Fig 17** It was during these repairs that the wall paintings were partially uncovered and their importance first realised (see chapter 3). A Steering Group with representatives from English Heritage, the County Council, the Council for the Care of Churches, and the Friends of St Mary's was formed to oversee works to the church and conservation of the paintings, assisted by wall painting experts from the Courtauld Institute of Art.

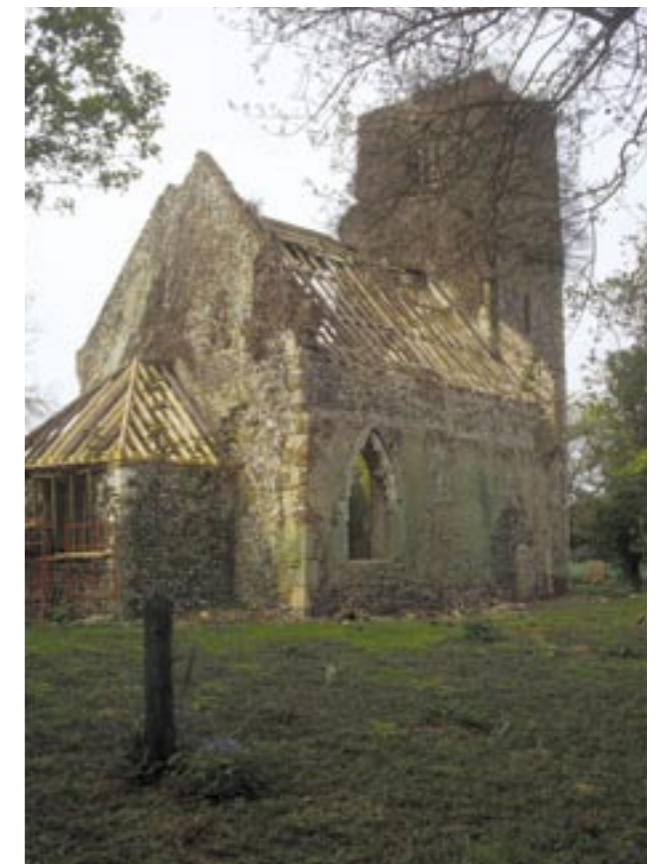
Fig 17: Repairs to the roofs under Norfolk County Council's Ruined Churches Repair programme in the 1990s

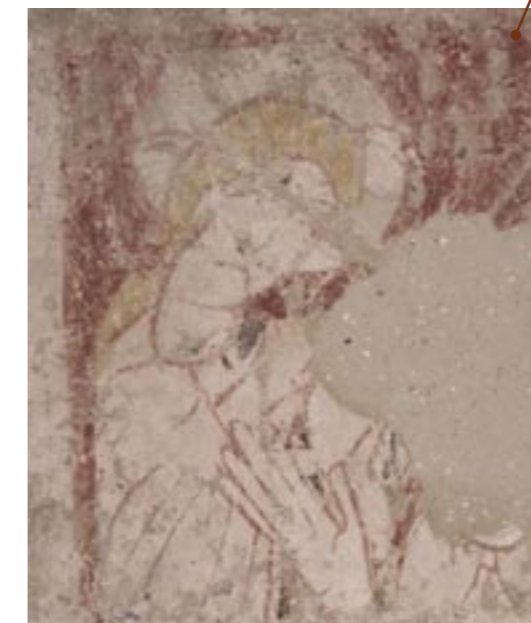
20a God creating Eve

Fig 20: North wall: The Old Testament

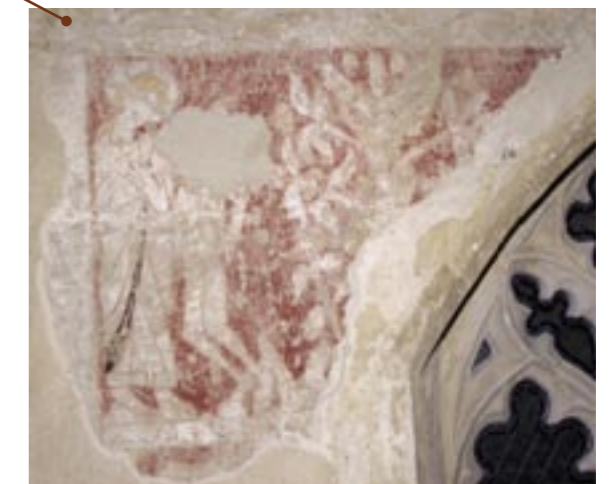
20b Creation of Eve

Fig 20b The large figure of God, with a crossed halo, holds up Eve, who has just been created from Adam's rib. He lies slumped against the Tree of Knowledge where fragmentary traces of the serpent can be seen entwined in the branches. It is likely that this painting was one in a series along the upper wall illustrating the events of Genesis, up to the Creation of Eve. The scheme may have continued with a further scene showing the Expulsion from the Garden of Eden, in the space now occupied by the window.

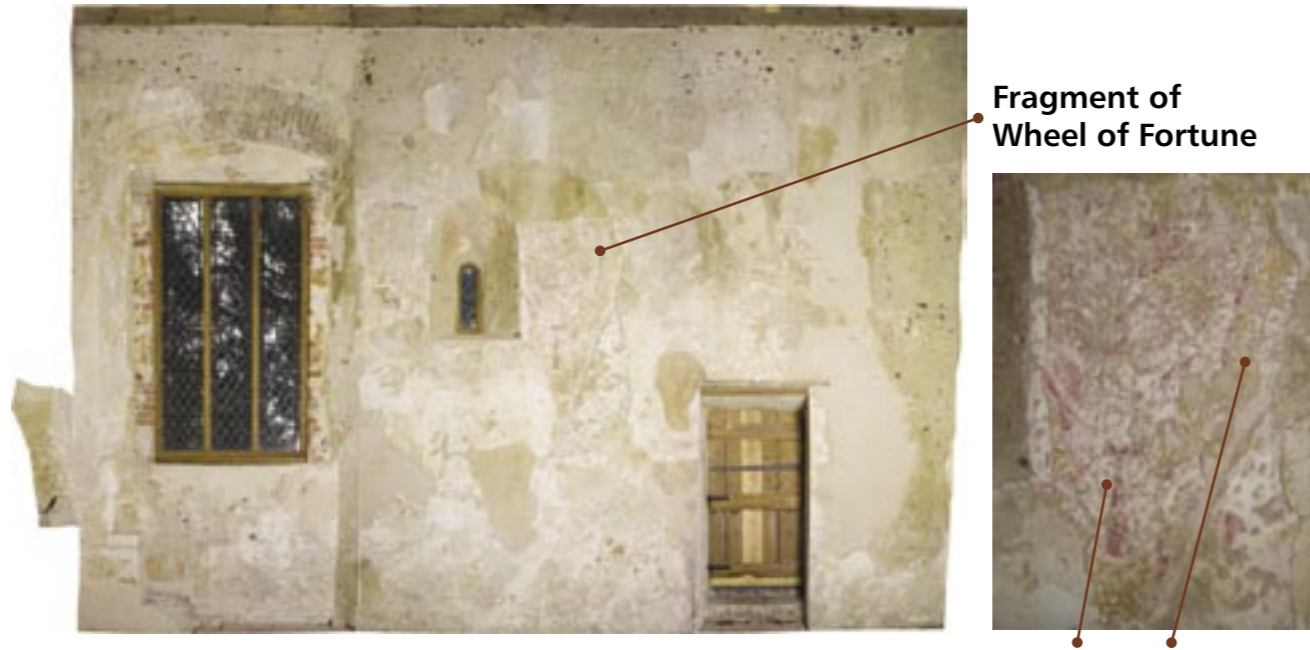
21a Skirt; Wheel

Fig 21: South wall: Wheel of Fortune

Fig 21a The man grasps the red-outlined spoke of a large yellow wheel, of which only a small part survives. The scale of the figure is much larger than in the schemes on the north wall, and would have been the most important picture on this side.

Much of the original painting scheme on this wall was lost when the arches through to the south aisle were punched through in the 12th century. **Fig 21**

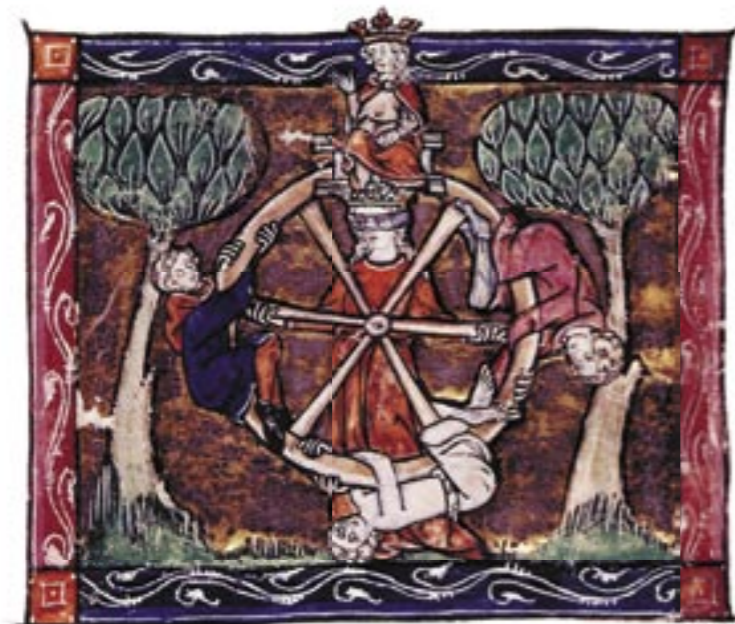
Fig 22: A Wheel of Fortune from the 14th century

The Wheel of Fortune was a popular image from the 12th to the 14th century, illustrating the progression of life. **Fig 22** However, this is the earliest known example of just a handful surviving in the county. Early depictions have a figure of blind Fortune in the centre, turning the wheel to which humanity is helplessly attached. In later versions this pre-Christian figure is replaced by God, in order to illustrate that all events are part of His divine plan.

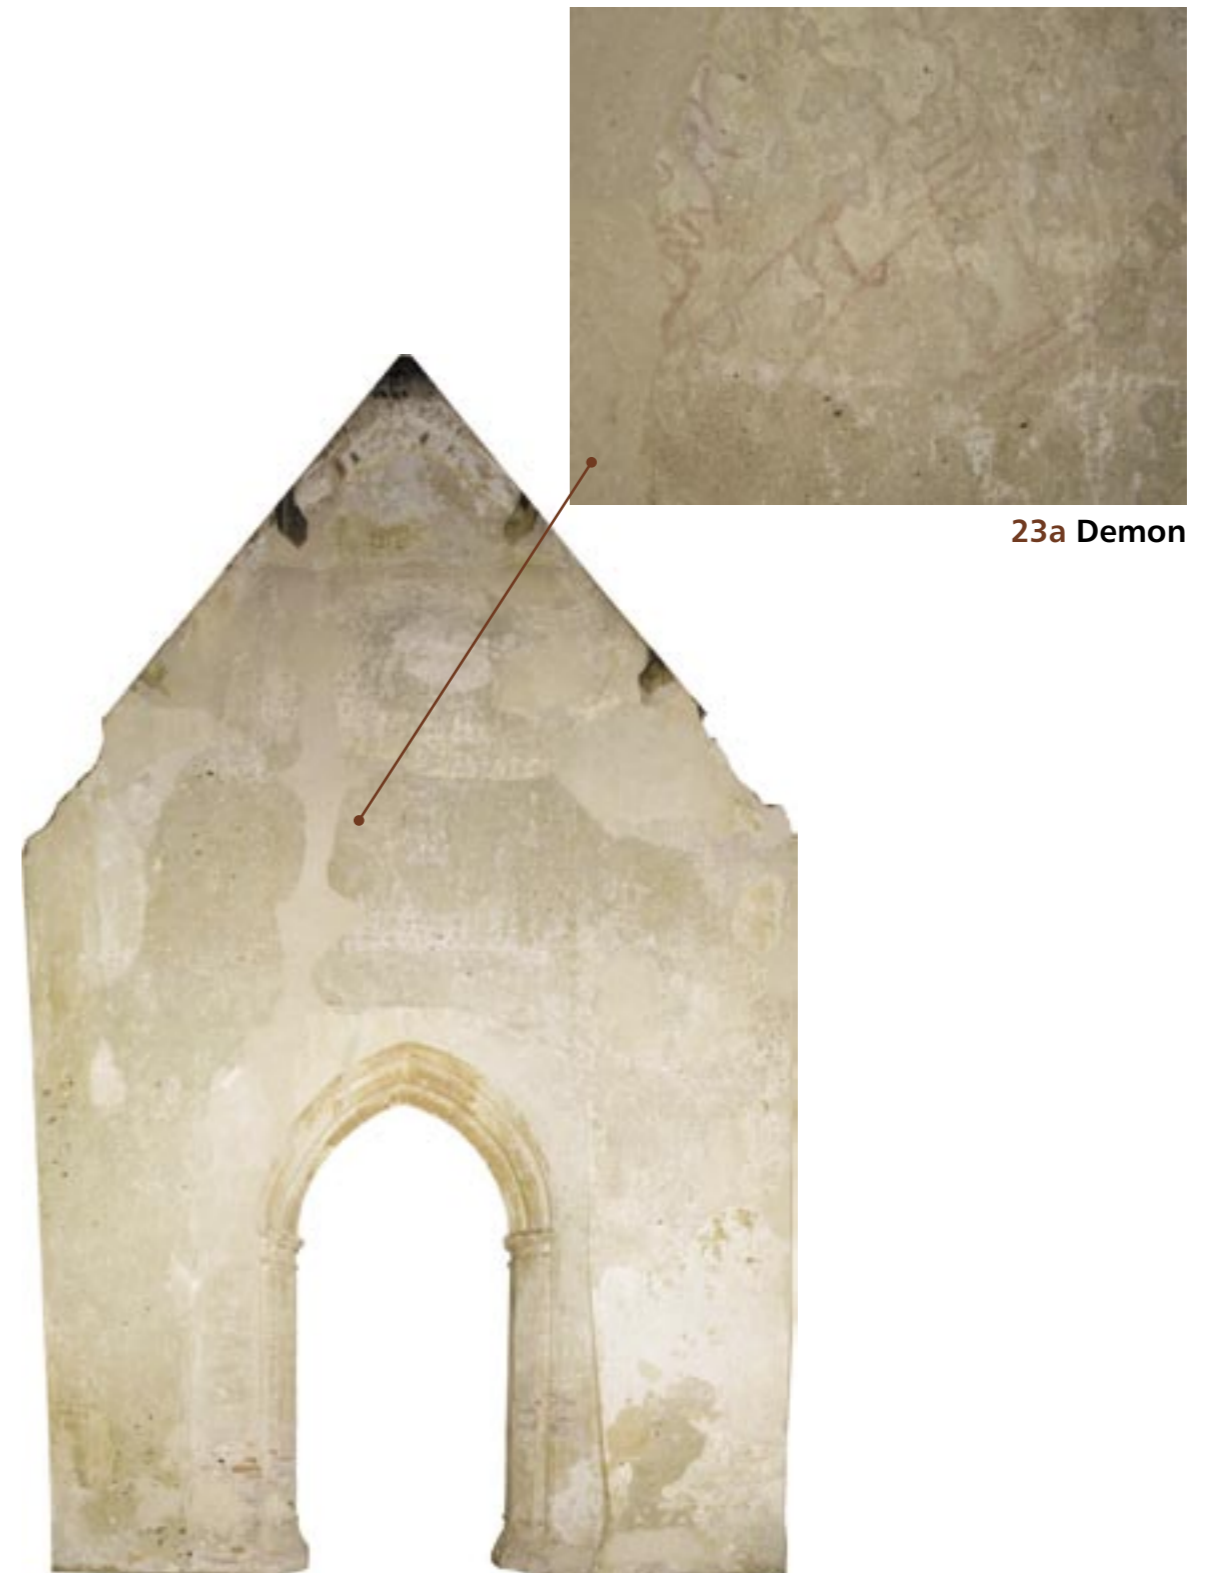
23a Demon

Only a few small areas of painting survive on this wall and it is not possible to identify a coherent theme. On the upper part of the west gable a demon with a hooked nose and spiky hair is holding a sinner upside down by the leg. **Fig 23a** Above this scene is a red and yellow chevron border marking the upper boundary of the scheme.

Fig 23: West wall

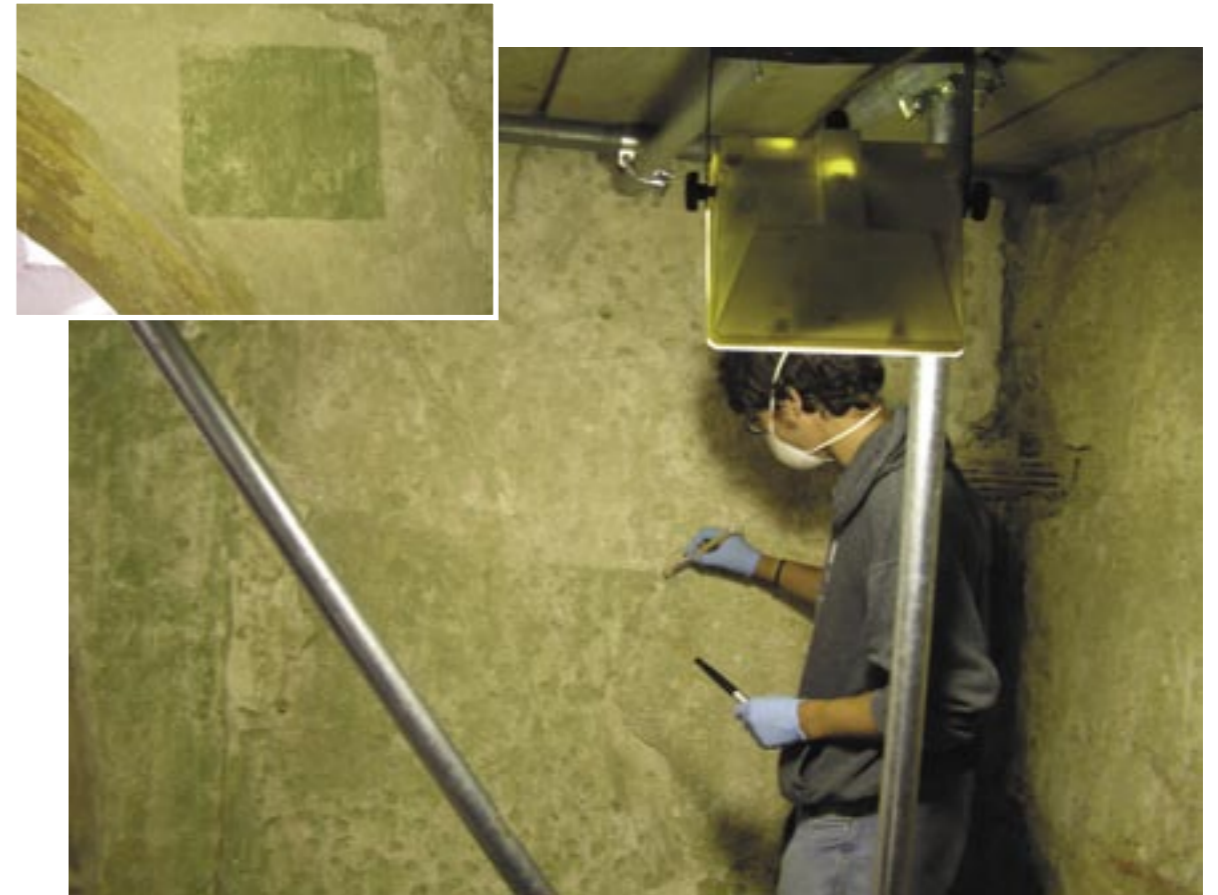
Figs 24: Careful removal of green micro-biological growth during conservation **(Inset) Fig 25:** Test area showing the difference between cleaned areas and green square of micro-biological growth

In this context, the conservation project of 2006 was restricted to stabilising the paintings as found. Tobit Curteis Associates carried out careful re-adhesion of plaster layers and paint layers, as well as removal of limewash residues and, most significantly, the extensive green micro-biological growth which obscured the paintings. This work has vastly improved their appearance, revealing for the first time the demons on the left hand of God, the Wheel of Fortune and the possible depiction of Noah's Ark. **Figs 24 & 25**
